Report 1974

UNIVERSAL FOLDED PLATE (UFP) STRUCTURAL SYSTEM

January 1970

**U. S. ARMY MOBILITY EQUIPMENT RESEARCH AND DEVELOPMENT CENTER
FORT BELVOIR, VIRGINIA**

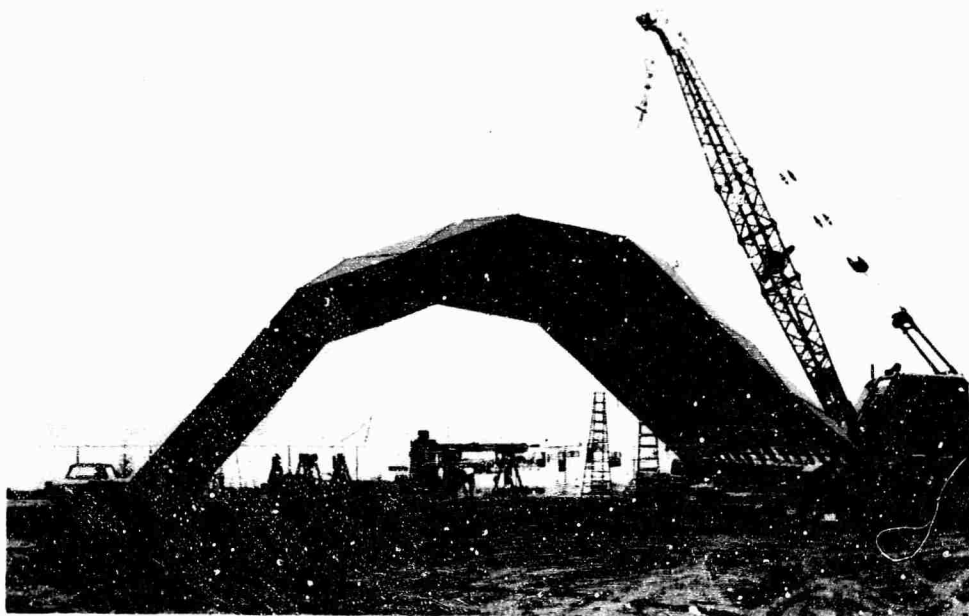
S4656

Fig. 20. Crane lift of structure at 60-percent completion.

During erection, the leading edge of the structure assembly had to be raised periodically and the wooden horses relocated to facilitate further placement of panels. The lifting was accomplished using a crane with a seven-point wire rope sling attached to a 1-in.-diameter steel rod. This steel rod was attached to the panel assembly by eyebolts (3/4-in. standard shoulder eyebolt) placed along the 40-ft building length (Figs. 16 and 18). The eyebolts were installed in place of the regular bolts at nodal points as required.
